Restoration, South East

Project Restoration, South East
 Sector Residential
 Location South East

Tile Product Clay Handmade Tile
 RTA Member Tudor Roof Tile Co Ltd

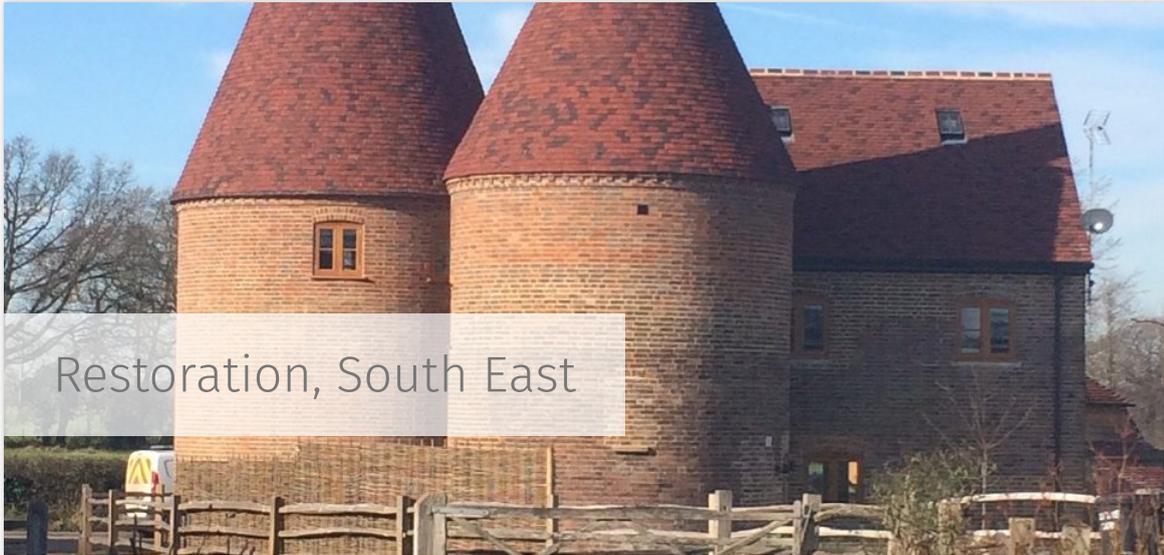
Dating from the nineteenth century, the buildings had originally consisted of a rectangular two-storey 9.6m x 6.6m brick barn with two different sized circular kilns, for drying hops grown in the area.

However, as they had not been used for many years, the buildings had fallen into disrepair and then suffered massive damage during the storms of 1987.

With the roofs completely destroyed, half of the brickwork on the larger south kiln missing and the brick walls and top courses on the barn and east kiln incomplete, there was a real danger that the remaining structure would collapse and ultimately be lost.

As the oast was curtilage listed, the new structure could not be enlarged beyond the footprint or envelope of the remaining buildings. Significant rebuilding work was undertaken using a mixture of traditional and modern materials in order to respect and complement local historic building methods rather than exactly replicate the original structure.

The new roofs were completely rebuilt and tiled with traditional clay Kent Peg tiles, which were manufactured by Tudor Roof Tiles to complement those on the adjacent buildings within the farm complex and a nearby converted barn. These were installed in a traditional mix of 75% red antique and 25% dark antique.

Once a derelict ruin located in the curtilage of the Grade II listed Lydens farmhouse, it has been carefully restored and converted into a characterful home, which blends with the rural landscape of the High Weald Area of Outstanding Natural Beauty.
